SpectroFlo[®] VERSION 3.2.1 RELEASE NOTES

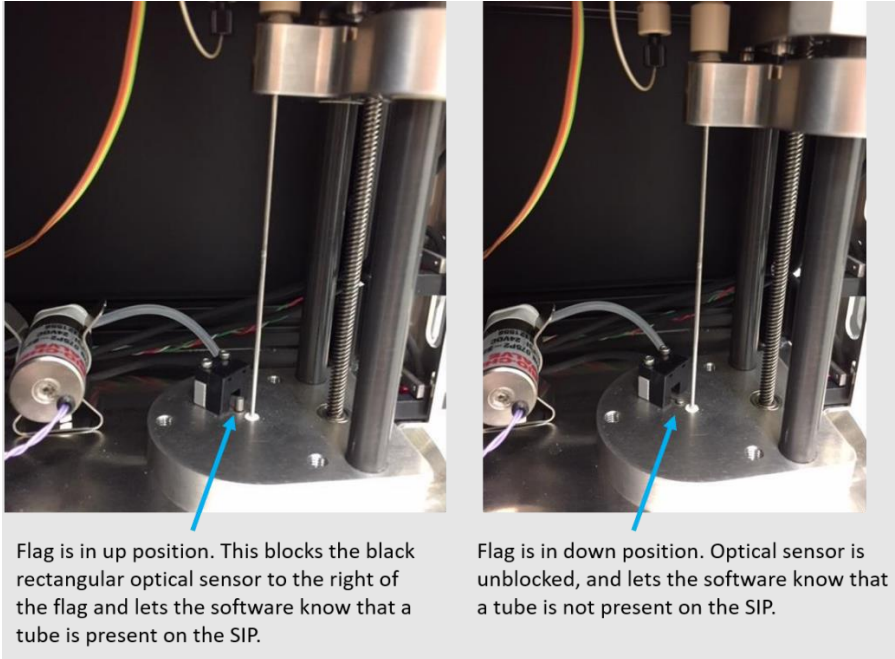
- **Automatic SIT Flush:** SIT flush does not always occur automatically between sample tubes. Occasionally, the mechanical flag that blocks and unblocks the tube sensor gets stuck in the tube present position. If you do not hear a SIT flush after unloading your tube, open the SIT door and check the position of the flag. If it is stuck in the up position when no tube is present, press the flag down. The SIT flush will then execute. If you notice a lot of salt buildup around the flag, let your Cytek Field Service Engineer know so they can clean it out for you.
